# No. 1482067.4R

CLIENT: Floorco Trading Ltd. 38 Galway St. Onehunga, Auckland	SAMPLE RECEIVED FROM: Floorco	Date Received: 28.9.23
Attn.: Terry Shi	SAMPLE DESCRIPTION: Flooring planks – Antico wood flooring assembly with D3 PVA adhesive applied in the joints.	
Client Order No.:	Client Reference:	1 of 4

## ISO 4760:2022(E) - LAMINATE FLOORING – TOPICAL MOISTURE RESISTANCE – ASSEMBLED JOINT (MODIFIED)

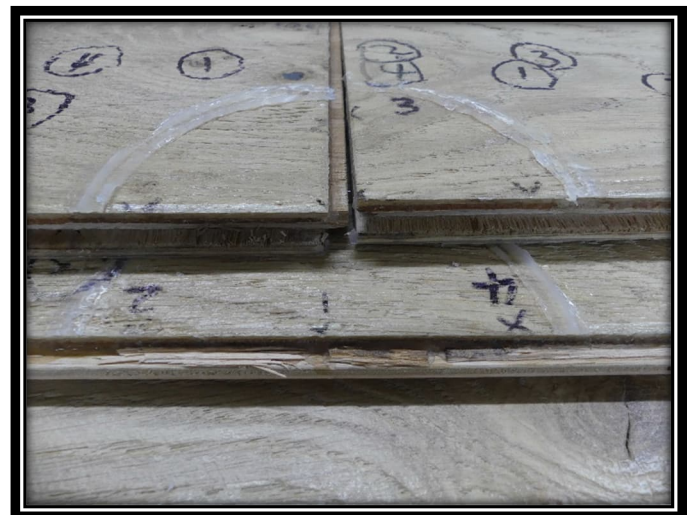
Recovered Swell (Disassembled)

Disassembly Observations:	Specimen 1	Specimen 2	Specimen 3
Migration of water along the upper surface:	No	No	No
Migration of water to the underside:	No	No	No
