No. 1480879.4R

SAMPLE DESCRIPTION:
Flooring plank – GL wood flooring assembly with D3
PVA adhesive applied in the joins.

ISO 4760:2022(E) - LAMINATE FLOORING – TOPICAL MOISTURE RESISTANCE – ASSEMBLED JOINT (MODIFIED)

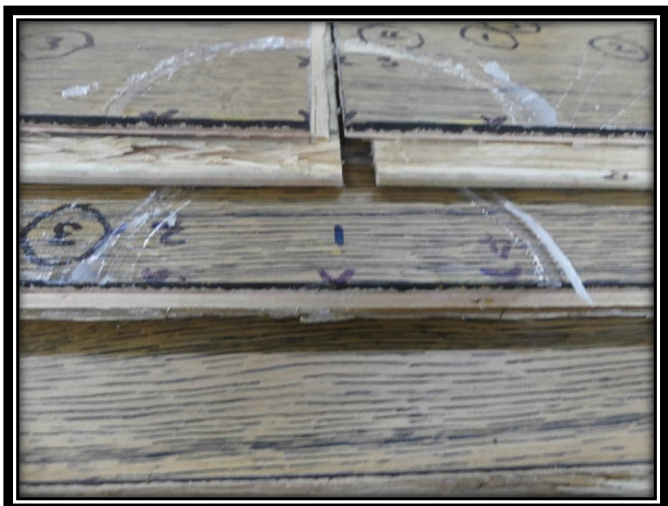
Recovered Swell (Disassembled)

Disassembly Observations:	Specimen 1	Specimen 2	Specimen 3
Migration of water along the upper surface:	Yes	No	No
Migration of water to the underside:	Yes	No	No
