# No. 1487249.3

SAMPLE DESCRIPTION:  
Flooring Planks – Berrylloc 8mm flooring assembly with  
DP3 PVA adhesive applied in the joints.

## ISO 4760:2022(E) - LAMINATE FLOORING – TOPICAL MOISTURE RESISTANCE – ASSEMBLED JOINT (MODIFIED)

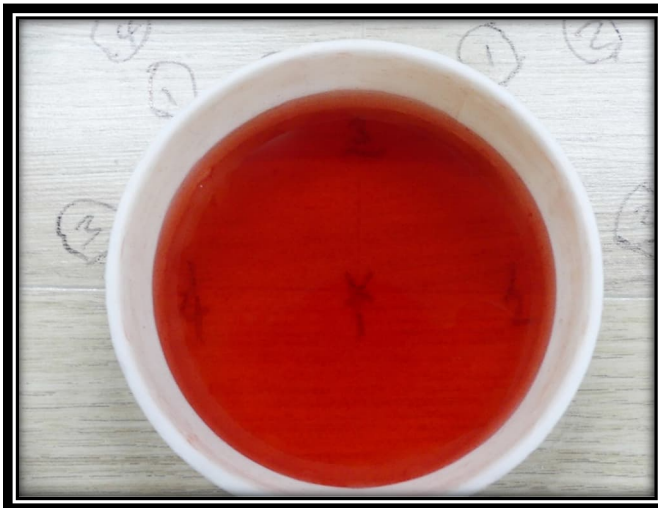
After 24 hrs With Water

Observations:	Specimen 1	Specimen 2	Specimen 3
Migration of water along the upper surface:	No	No	No
Migration of water to the underside:	No	No	No

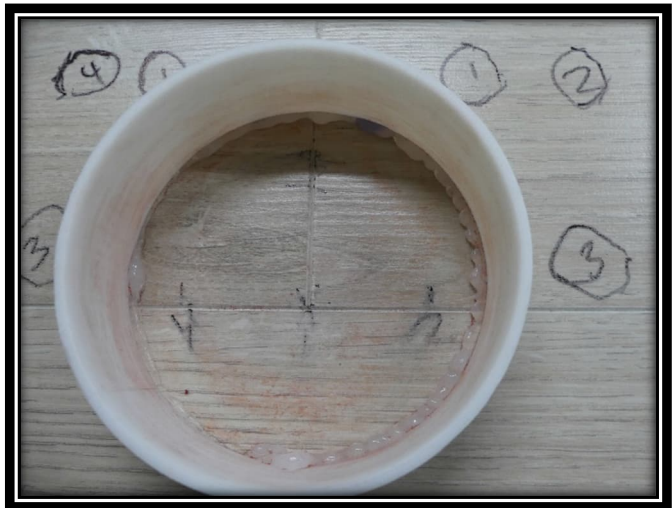
Wet Swell

Quantitative Results:	Wet Swell (mm)			Recovered Swell (mm)		
	Specimen 1	Specimen 2	Specimen 3	Specimen 1	Specimen 2	Specimen 3
Final Average Results (Positions 2 to 4)	0.01	0.03	0.01	0.00	0.00	0.00
Final Results (Position 1)	0.00	0.00	0.00	0.00	0.00	0.01

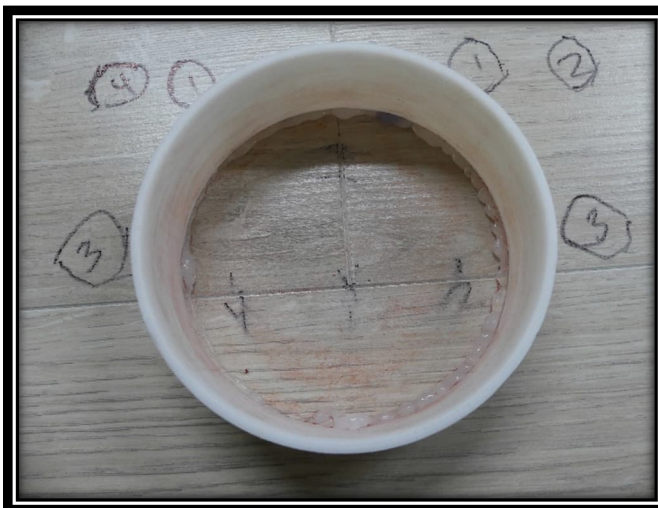
Recovered Swell

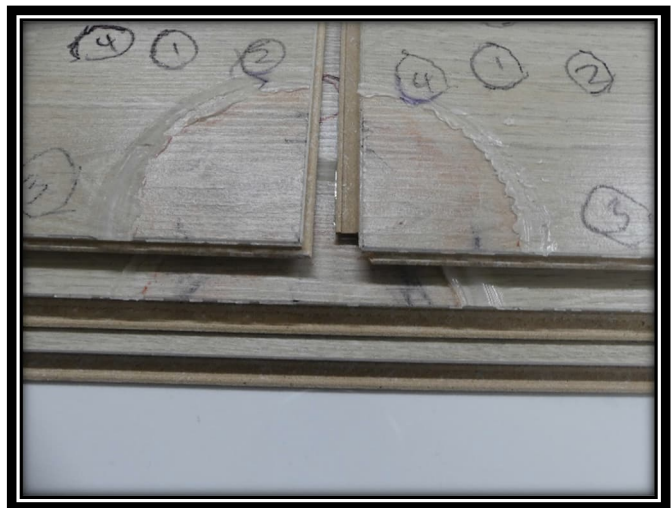
Recovered Swell (Disassembled)

Disassembly Observations:	Specimen 1	Specimen 2	Specimen 3
Migration of water along the upper surface:	No	No	No
Migration of water to the underside:	No	No	No
