No. 1488381.3

SAMPLE DESCRIPTION:
Flooring Planks – BinyI PRO 8mm laminate flooring
assembly with D3 PVA adhesive applied in the joints.

ISO 4760:2022(E) - LAMINATE FLOORING – TOPICAL MOISTURE RESISTANCE – ASSEMBLED JOINT (MODIFIED)

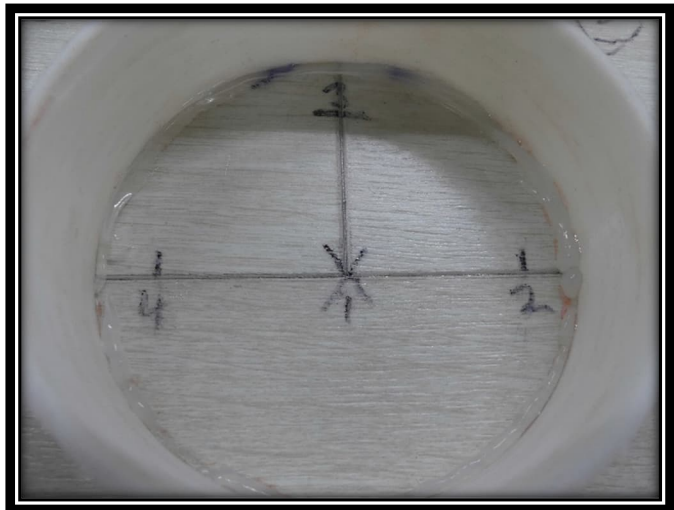
Wet Swell

| Quantitative Results: | Wet Swell (mm) | | | Recovered Swell (mm) | | |
|---|---|---|---|---|---|---|
| Final Average Results (Positions 2 to 4) | 0.08 | 0.10 | 0.02 | 0.04 | 0.07 | 0.01 |
| Final Results (Position 1) | 0.12 | 0.08 | 0.00 | 0.07 | 0.05 | 0.03 |
