No. 1441929.5

SAMPLE DESCRIPTION:
Flooring Planks – 8mm SPC

ISO 4760:2022(E) - LAMINATE FLOORING – TOPICAL MOISTURE RESISTANCE – ASSEMBLED JOINT (MODIFIED)

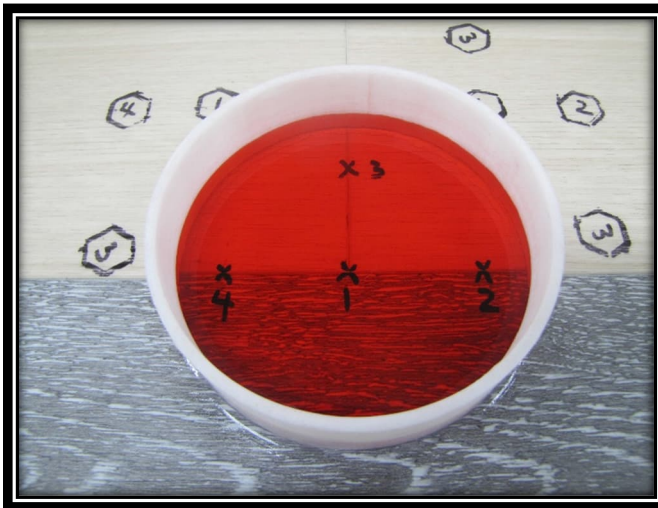
24 hrs With Water

Weights were placed on the outer corners of the test specimens to keep the samples flat throughout the test procedure. 100 mls of dye solution was applied onto the sample surface. It was poured into a cylinder 100mm diameter placed in the centre of the sample at the "T joint." Sealant was used at the plank/cylinder interface to avoid leakage.

The sample was placed on white paper towels prior to testing to enable detection of any dye penetration through the joints.

The sample was left at 20°C, 65% Relative Humidity room conditions for 24 hours after the dye was added and then examined for dye penetration through the backing (not 23°C, 50% RH as stated in the method).

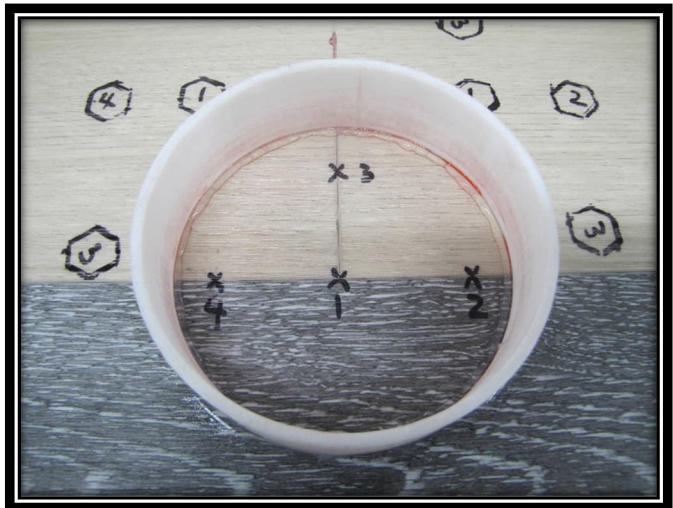
Wet Swell

Quantitative measurements are used to calculate surface swell in mm (within 15 minutes after water removal) and recovery swell (24 hours after removal of water).

Quantitative Results:	Wet Swell (mm)			Recovered Swell (mm)		
	Specimen 1	Specimen 2	Specimen 3	Specimen 1	Specimen 2	Specimen 3
Final Average (Positions 2 to 4)	0.02	*	0.01	0.03	*	0.04
Final average (Position 1)	0.06	*	0.00	0.06	*	0.02

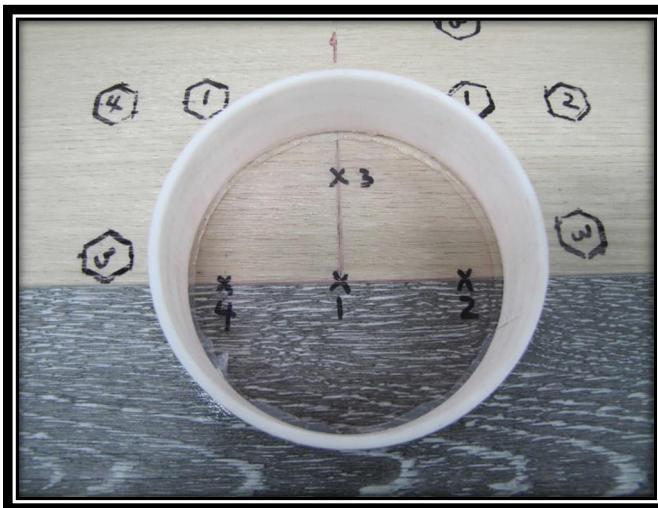
Recovered Swell

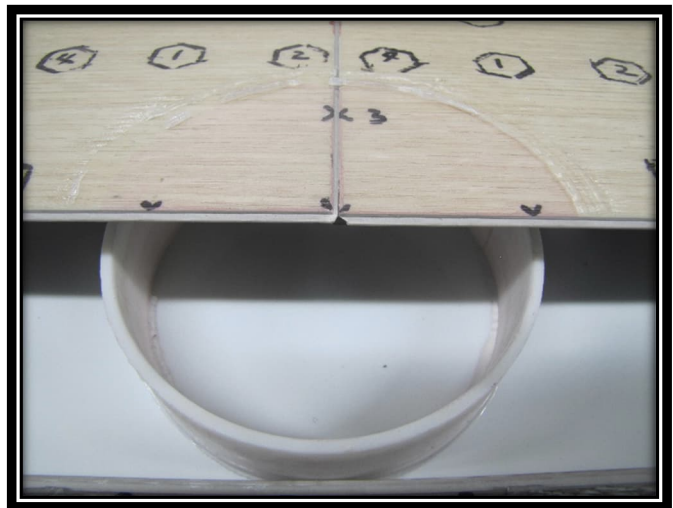
Recovered Swell (Disassembled)

Disassembly Observations:	Specimen 1	Specimen 2	Specimen 3
Migration of water along the upper surface:	No	No	No
Migration of water to the underside:	No	Yes	No
