LABORATORY MEASUREMENT OF THE REDUCTION OF TRANSMITTED IMPACT SOUND OF SPC FLOORING ON CORK/RUBBER UNDERLAY

Test report ID: T2219-1

LABORATORY MEASUREMENT OF THE REDUCTION OF TRANSMITTED IMPACT SOUND BY FLOOR COVERINGS ON A STANDARD FLOOR

Client: Floorco

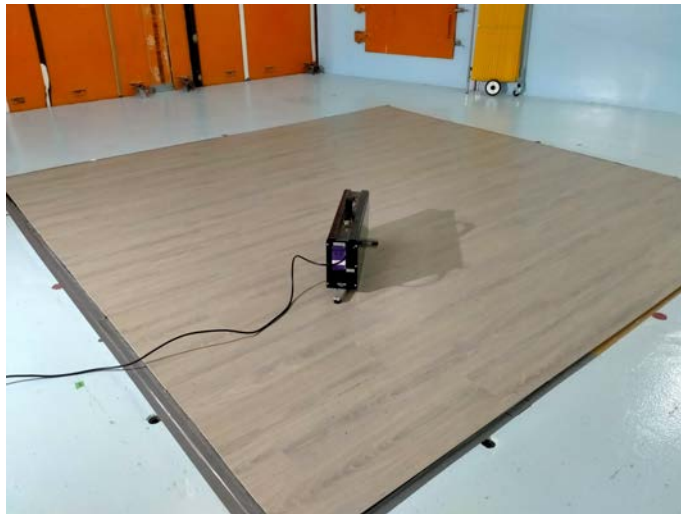
Figure 2.1: Sample installed on chamber floor with tapping machine

The normalized impact sound pressure levels are obtained in accordance with the recommendations of ISO standard 10140-3 “Measurements of impact sound insulation.” The BK3204 tapping machine is placed sequentially in four different positions on the floor. The impact sound pressure level is measured in the room below the floor, using a rotating microphone, in third octave frequency bands. The impact sound pressure levels are normalized against the room absorption. The room absorption is calculated from the reverberation time and room volume. The reverberation time is measured from the decay of a steady state sound field. Corrections are applied, where necessary, for airborne sound transmission and background noise. The airborne sound transmission is determined using a loudspeaker and the microphone.

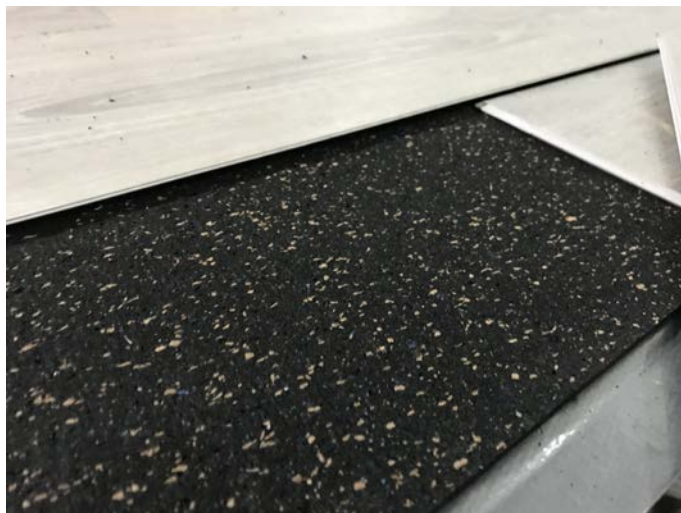
Figure 2.2: Sample detail

First layer (wearing surface): Brand name: *Atwood floors SPC flooring*. Flooring comprising: Stone Polymer Composite (SPC) with overall plank thickness of 5.7 mm including cushion backing, click locking installation system loose laid on underlay.

Second layer (underlay): Brand name: *Floorco High density Acoustic Rubber cork underlay*. Underlay comprising: 5 mm thick 1000 mm wide rubber/cork mix underlay loose laid and butt jointed on concrete floor slab (underlay measured density of 427kg/m³)

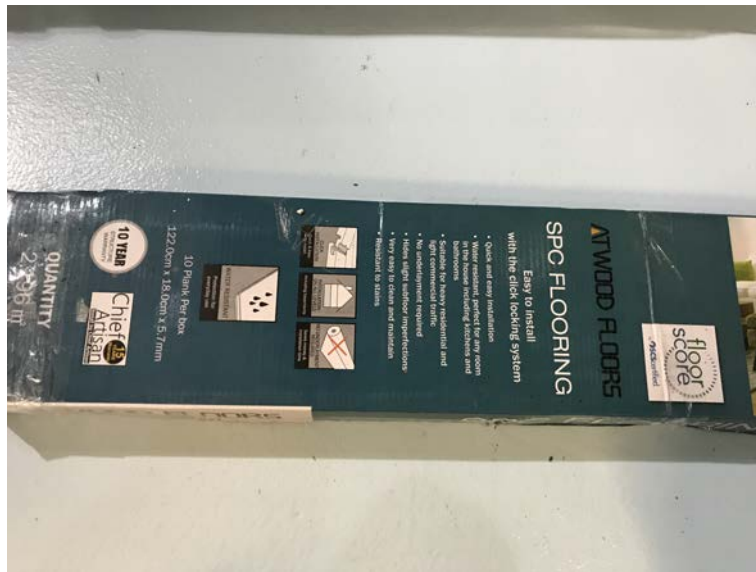
Figure 2.3: SPC flooring detail

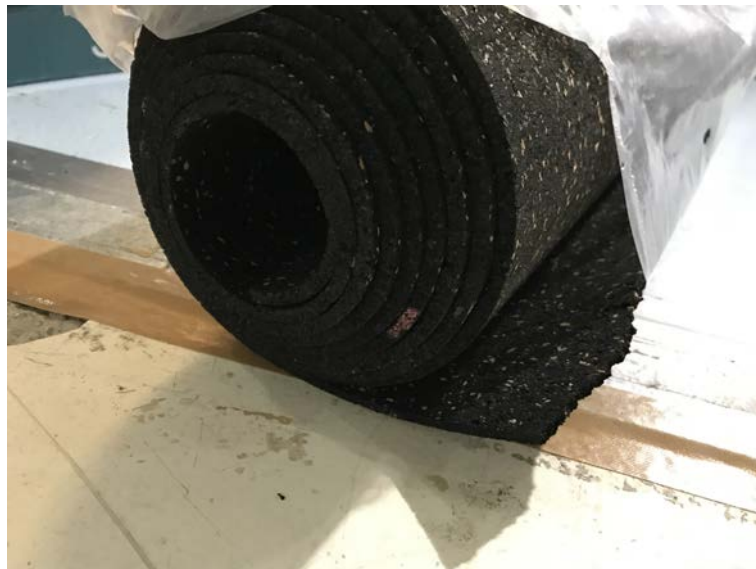
Figure 2.4: Underlay detail
