LABORATORY MEASUREMENT OF THE REDUCTION OF TRANSMITTED IMPACT SOUND OF ENGINEERED WOOD FLOORING ON CORK/RUBBER UNDERLAY

Test report ID: T2229-1

LABORATORY MEASUREMENT OF THE REDUCTION OF TRANSMITTED IMPACT SOUND BY FLOOR COVERINGS ON A STANDARD FLOOR

Reduction of impact sound pressure level according to ISO 10140-3

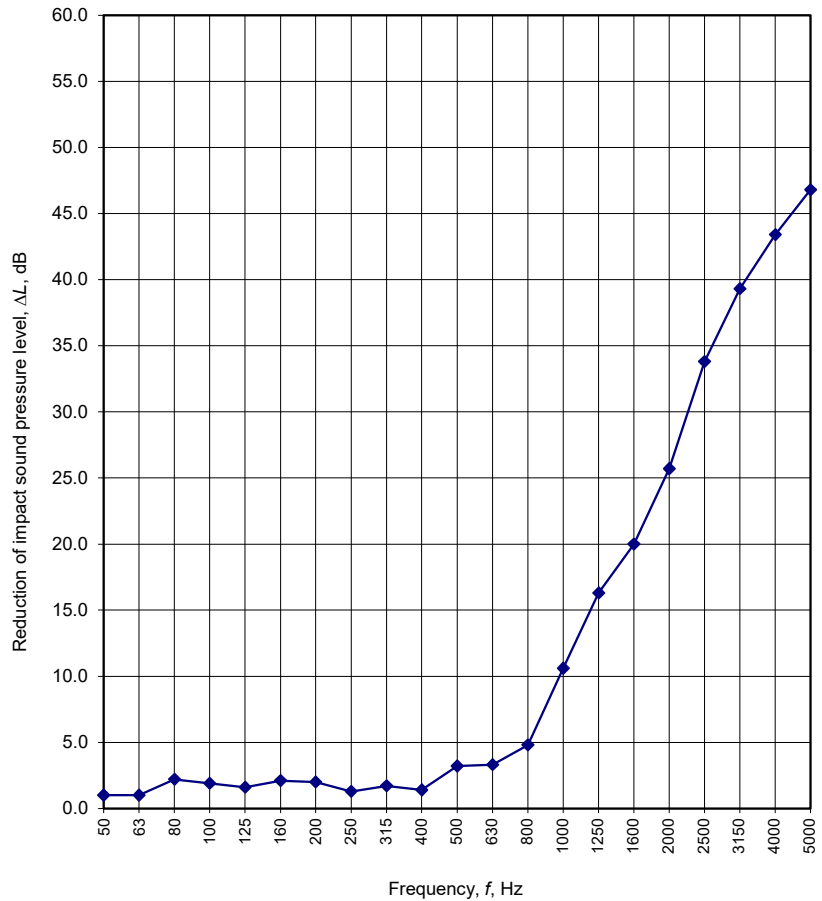
Frequency <i>f</i> Hz	<i>L</i> _{<i>n,0</i>} One-third octave dB	ΔL One-third octave dB
50	54.8	1.0
63	51.0	1.0
80	60.9	2.2
100	64.8	1.9
125	64.0	1.6
160	67.6	2.1
200	67.0	2.0
250	69.9	1.3
315	70.9	1.7
400	71.2	1.4
500	79.2	3.2
630	76.3	3.3
800	72.6	4.8
1000	72.5	10.6
1250	73.2	16.3
1600	78.9	20.0
2000	78.7	25.7
2500	76.2	33.8
3150	75.5	39.3
4000	71.6	43.4
5000	67.8	46.8

Notes: #N/A = Value not available. **Bold** values are used to calculate ΔL_w .

< indicates that the true value is lower.
*L*_{*n,0*} are the bare floor impact sound levels.

Rating according to ISO 717-2:

$\Delta L_w = 15$ dB

$C_{1,\Delta} = 10$ dB

$C_{1,r} = -1$ dB

$C_{1,50-2500} = -1$ dB

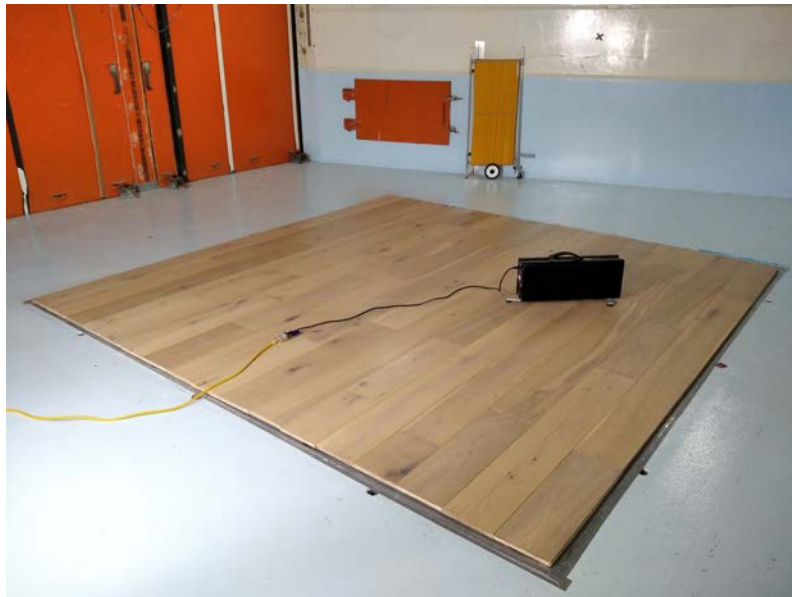
Figure 2.1: Sample installed on chamber floor with tapping machine

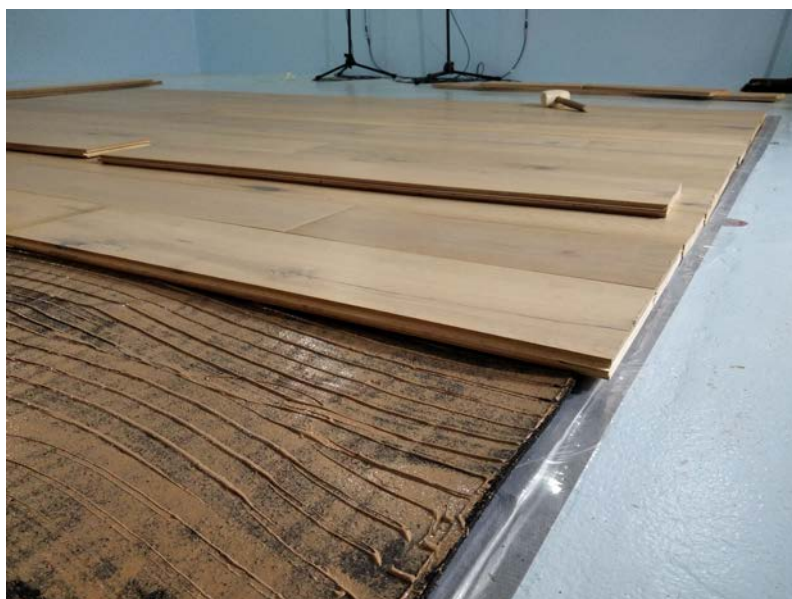
Figure 2.2: Sample detail

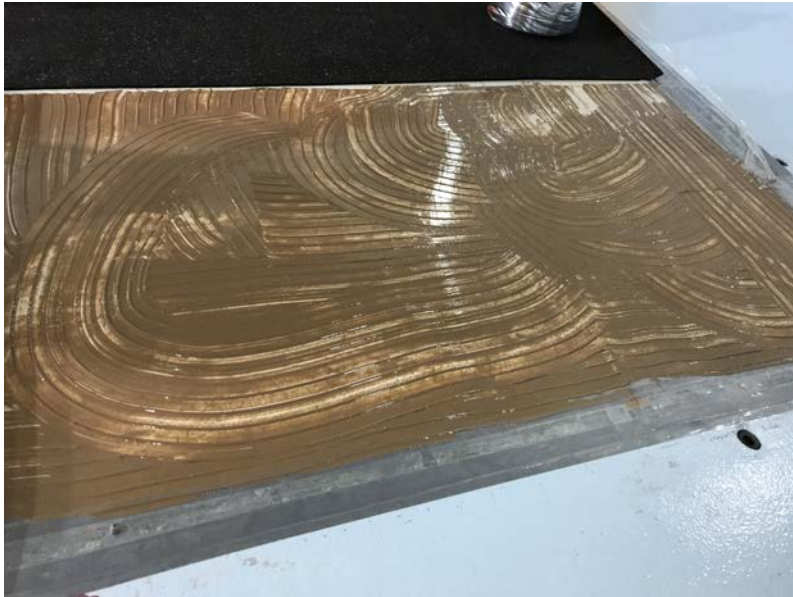
Figure 2.3: adhesive applied to reference floor for underlay

Second layer (underlay): Brand name: *Floorco High density Acoustic Rubber cork underlay*. Underlay comprising: 5 mm thick x 1000 mm wide rubber/cork mix underlay (measured density of 427kg/m³) butt jointed and glued to reference concrete floor slab with *Marldon MXA200 Wood Floor Adhesive* applied with a 25 x 6.5mm notched trowel. Adhesive left to cure for 5 days.

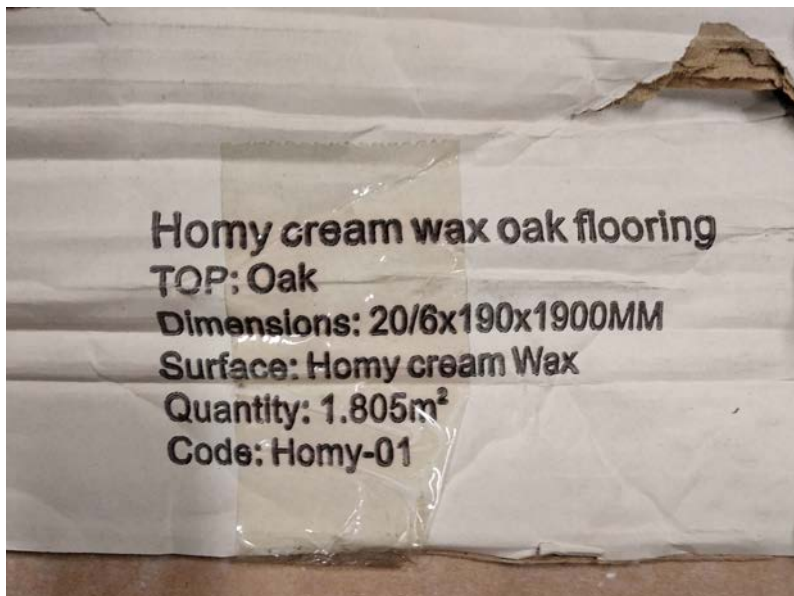
Figure 2.4: Engineered wood flooring detail

First layer (wearing surface): Brand name: *Homy 2020 Cream Wax Oak Flooring*. Flooring comprising: engineered wood with overall plank thickness of 20 mm including a 6 mm top layer of oak, tongue and groove installation system glued to underlay with *Marldon MXA200 Wood Floor Adhesive* applied with a 25 x 6.5mm notched trowel. Adhesive left to cure for 5 days.

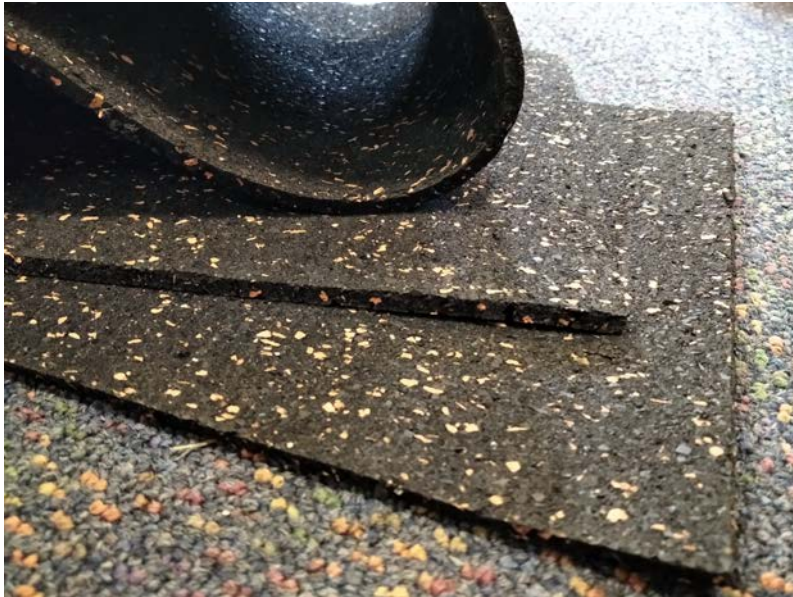
Figure 2.5: Underlay detail

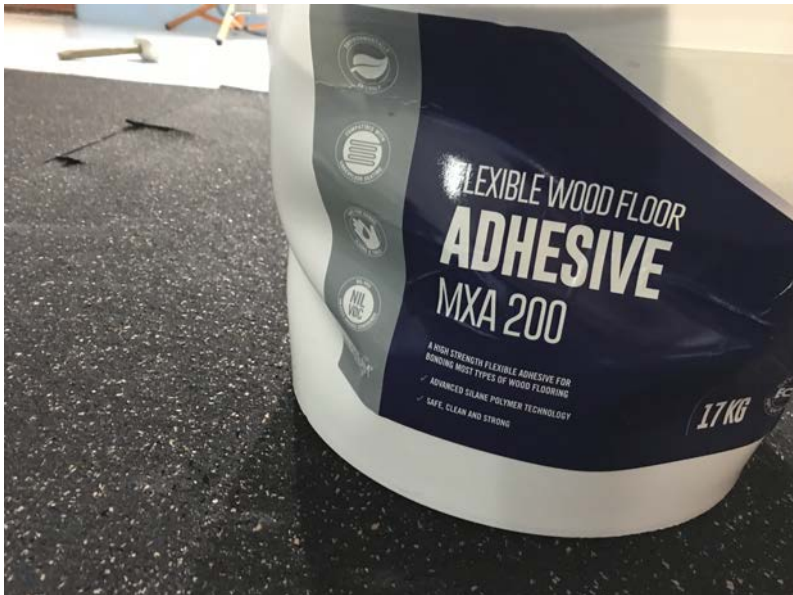
Figure 2.6: Wood floor adhesive detail

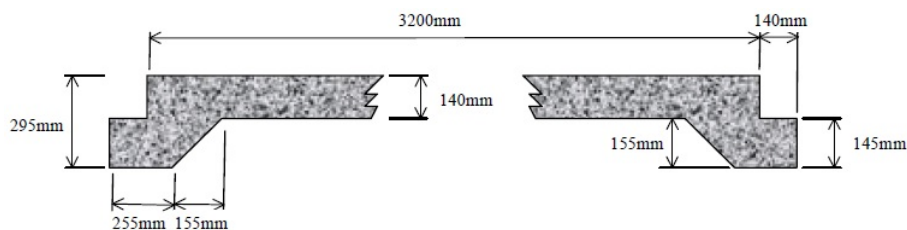
Figure 4.1: Floor/ceiling system

The floor covering is installed on a concrete floor plug that is positioned in the opening between two large reverberation chambers – chambers B and A. These chambers are vibration isolated from each other, which results in a structural discontinuity at the middle of the test opening. This gap is covered over by a wooden collar, which seals the gap and provides for ease of fixing of samples. The concrete floor plug is made of concrete reinforced with steel and is covered with a layer of hard resin. The dimensions of the floor plug are given in the following elevation diagram. If the floor covering is flexible, three samples to be tested are laid by the client following the techniques normally used in practice for that type of floor covering, with the constraint that the concrete floor plug be protected by a layer of thin self adhesive plastic tape if necessary.

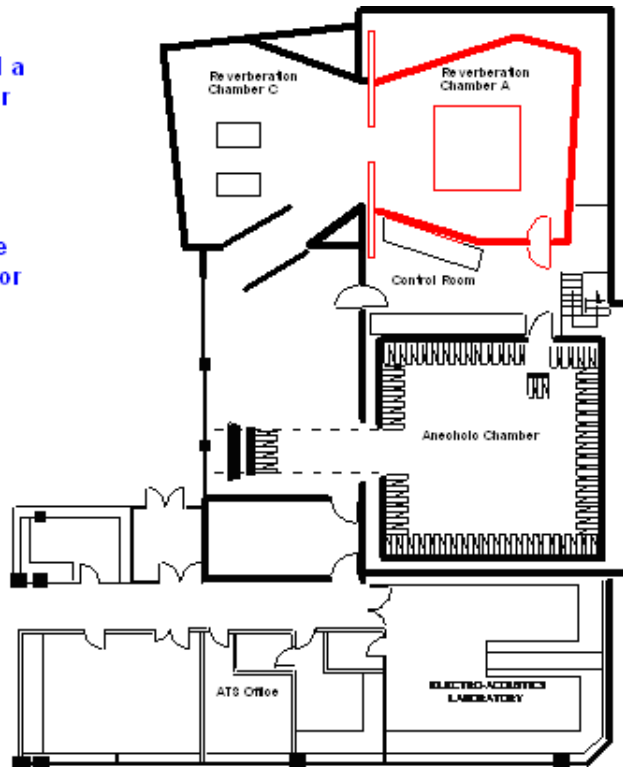
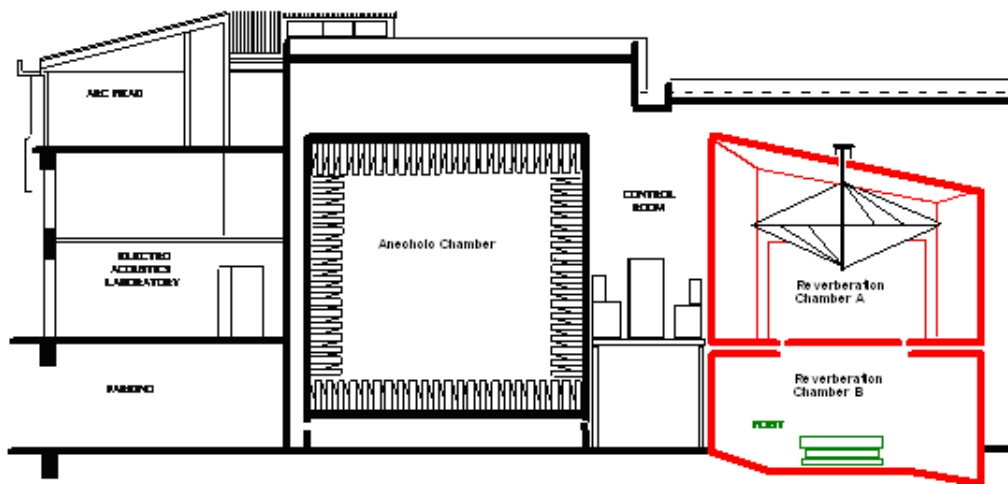
Figure 5.1: Acoustic Testing Service, The red lines show chambers used in measurements

There are three large interconnected reverberation chambers at the Acoustics Research Centre, two at ground level (Chambers C and A) and the third (Chamber B) below A.

All three reverberation chambers may be described as hexagonal prisms; each having 6 vertical sided walls, perpendicular to the floor. The roofs of chamber A and C are plane, but inclined at 12 degrees from horizontal. Chamber B has a plane, horizontal roof which is the floor of chamber A above it. The floor of chamber B is also horizontal, but has two angled sections at its north west and south east ends. The centre section is horizontal because a floor jack is installed there. The floor jack may be raised hydraulically to the ceiling of chamber B, the centre of which consists of a floor plug between the two chambers. This plug may be disconnected from chamber A and lowered down into chamber B, leaving a 3.2m x 3.2 m opening between the two chambers. This allows for the measurement of airborne and impact insulation of floor and roof elements.

The three Reverberation Chambers are linked by heavy steel doors and a removable Standard Industrial Floor Section which is removed and repositioned by a hydraulic hoist. The three chambers are vibration isolated from one another so that sound can only pass from one to the other via the intervening Test Wall or Test Floor/Ceiling Section.
