# No. 1487248.5

SAMPLE DESCRIPTION:  
Flooring Planks – 8MIL 8mm flooring assembly with D3  
PVA adhesive applied in the joints.

## ISO 4760:2022(E) - LAMINATE FLOORING – TOPICAL MOISTURE RESISTANCE – ASSEMBLED JOINT (MODIFIED)

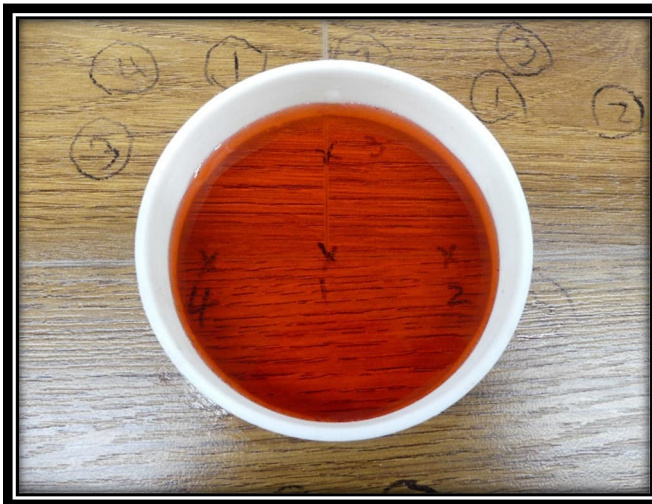
After 24 hrs With Water

The sample was left at 20°C, 65% Relative Humidity room conditions for 24 hours after the dye was added and then examined for dye penetration through the backing (not 23°C, 50% RH as stated in the method).

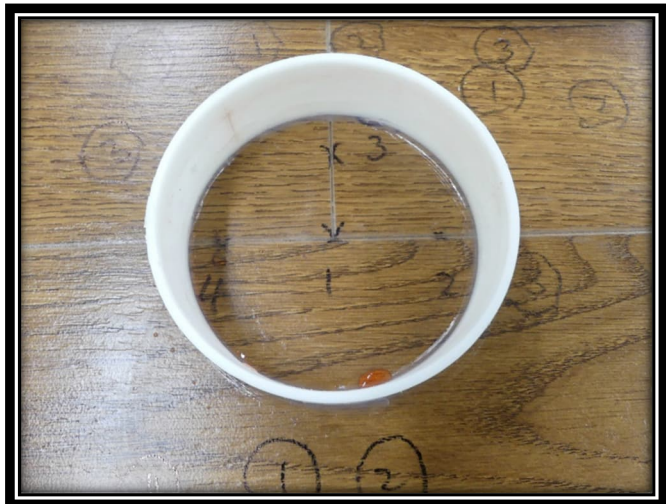
Wet Swell

- 1 = No change - Little to no noticeable change in edge swell or panel surface lift
- 2 = Slight swelling - Slight swelling, small ridge along one or more joints, very little if any panel surface lift
- 3 = Moderate - Noticeable edge swelling and some panel surface lift extending away from joint
- 4 = Objectional - Severely raise edge and swelling extending noticeably under the panel surface
- 5 = Failed test - Water leaked out of the ring, leaving no continuous film of water inside the ring  
(this grade is given even if there is no swell of the edge joint)

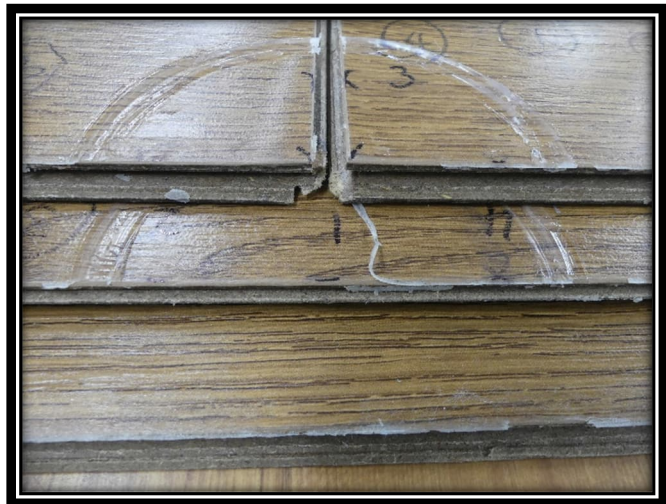
Recovered Swell (Disassembled)
