No. 1482065.8R

SAMPLE DESCRIPTION:
Flooring planks – Atwood wood flooring assembly with
D3 PVA adhesive applied in the joints.

ISO 4760:2022(E) - LAMINATE FLOORING – TOPICAL MOISTURE RESISTANCE – ASSEMBLED JOINT (MODIFIED)

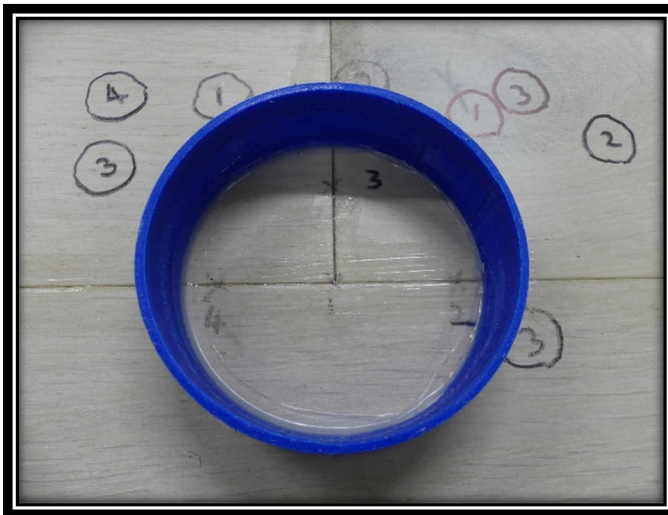
Recovered Swell
