# No. 1488371.4

SAMPLE DESCRIPTION:  
Flooring Planks – Barlinek Wood flooring assembly with  
D3 PVA adhesive applied in the joints.

## ISO 4760:2022(E) - LAMINATE FLOORING – TOPICAL MOISTURE RESISTANCE – ASSEMBLED JOINT (MODIFIED)

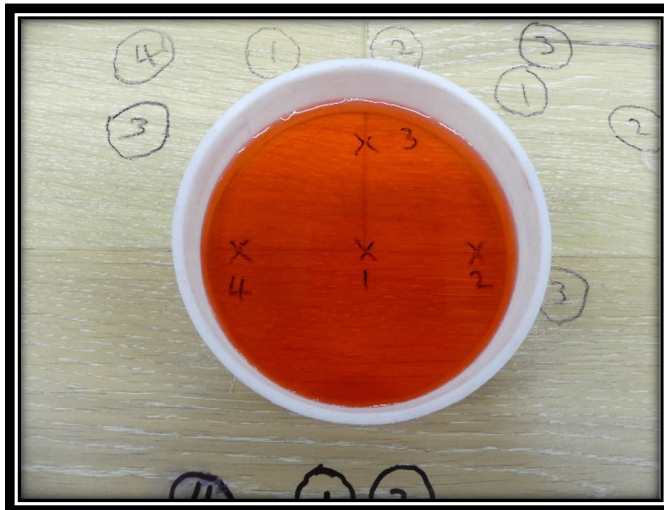
After 24 hrs With Water

100 mls of dye solution was applied onto the sample surface. It was poured into a cylinder 100mm diameter placed in the centre of the sample at the "T joint." Sealant was used at the plank/cylinder interface to avoid leakage.

The sample was left at 20°C, 65% Relative Humidity room conditions for 24 hours after the dye was added and then examined for dye penetration through the backing (not 23°C, 50% RH as stated in the method).

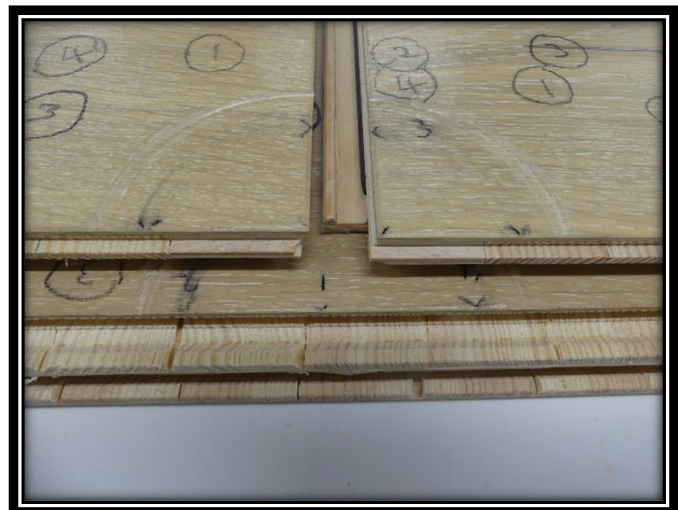
Recovered Swell (Disassembled)
