# No. 1482066.6R

SAMPLE DESCRIPTION:  
Flooring planks – Duke wood flooring assembly with D3  
PVA adhesive applied in the joins.

## ISO 4760:2022(E) - LAMINATE FLOORING – TOPICAL MOISTURE RESISTANCE – ASSEMBLED JOINT (MODIFIED)

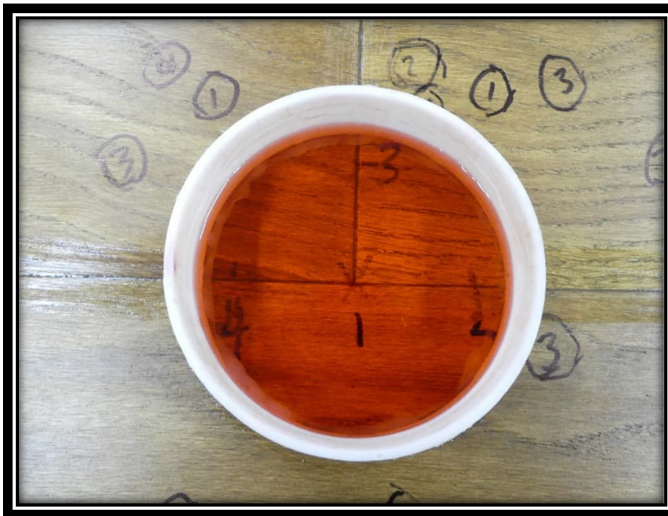
After 24 hrs With Water

100 mls of dye solution was applied onto the sample surface. It was poured into a cylinder 100mm diameter placed in the centre of the sample at the "T joint." Sealant was used at the plank/cylinder interface to avoid leakage.

The sample was left at 20°C, 65% Relative Humidity room conditions for 24 hours after the dye was added and then examined for dye penetration through the backing (not 23°C, 50% RH as stated in the method).

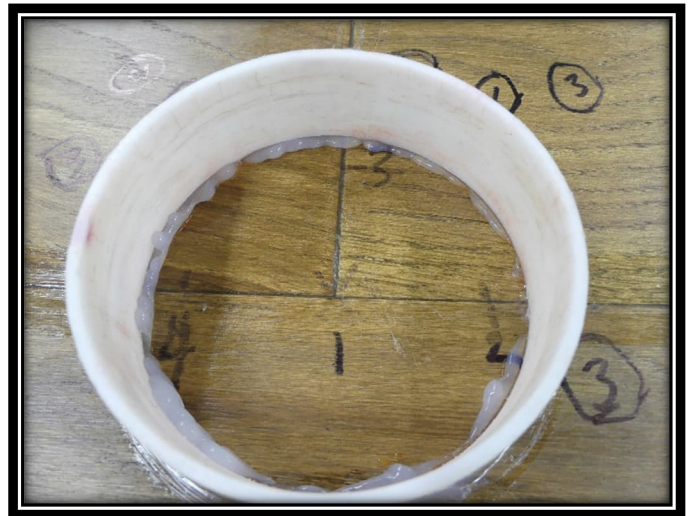
Wet Swell

- 1 = No change - Little to no noticeable change in edge swell or panel surface lift
- 2 = Slight swelling - Slight swelling, small ridge along one or more joints, very little if any panel surface lift
- 3 = Moderate - Noticeable edge swelling and some panel surface lift extending away from joint
- 4 = Objectional - Severely raise edge and swelling extending noticeably under the panel surface
- 5 = Failed test - Water leaked out of the ring, leaving no continuous film of water inside the ring  
(this grade is given even if there is no swell of the edge joint)

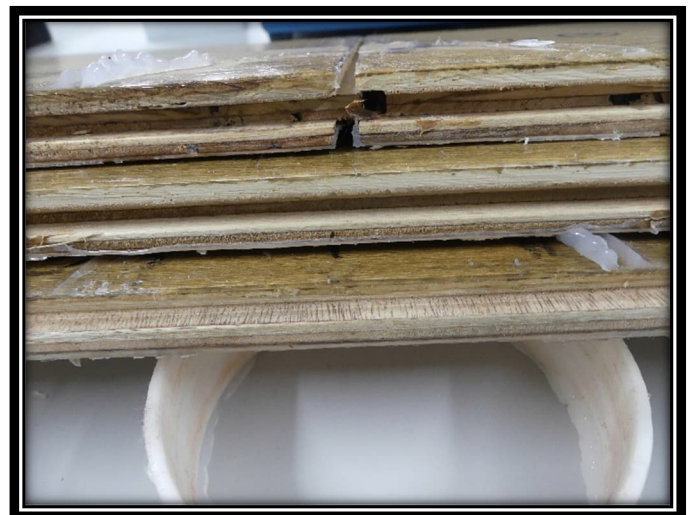
Recovered Swell (Disassembled)
