Flooring Planks - KRONO 10mm laminate flooring

assembly with D3 PVA adhesive applied in the joints.

ISO 4760:2022(E) - LAMINATE FLOORING - TOPICAL MOISTURE RESISTANCE - ASSEMBLED JOINT (MODIFIED)

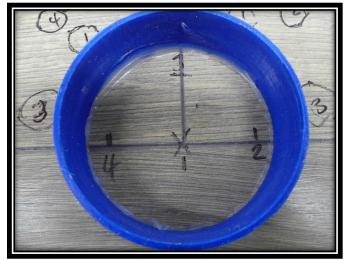
After 24 hrs With Water

Wet Swell

The sample was cut into pieces then connected using the profiled locking edges and fastened into an assembled floating "T joint" configuration as per the test method. The testing was performed in triplicate.

100 mls of dye solution was applied onto the sample surface. It was poured into a cylinder 100mm diameter placed in the centre of the sample at the "T joint." Sealant was used at the plank/cylinder interface to avoid leakage.
